Philip Williams & Associates, Ltd.
Consultants in Hydrology

**HYDROLOGY AND WATER QUALITY:
BERKELEY AQUATIC PARK**

Jeffrey Haltiner, Ph.D., P.E.
Principal

January 3, 1990

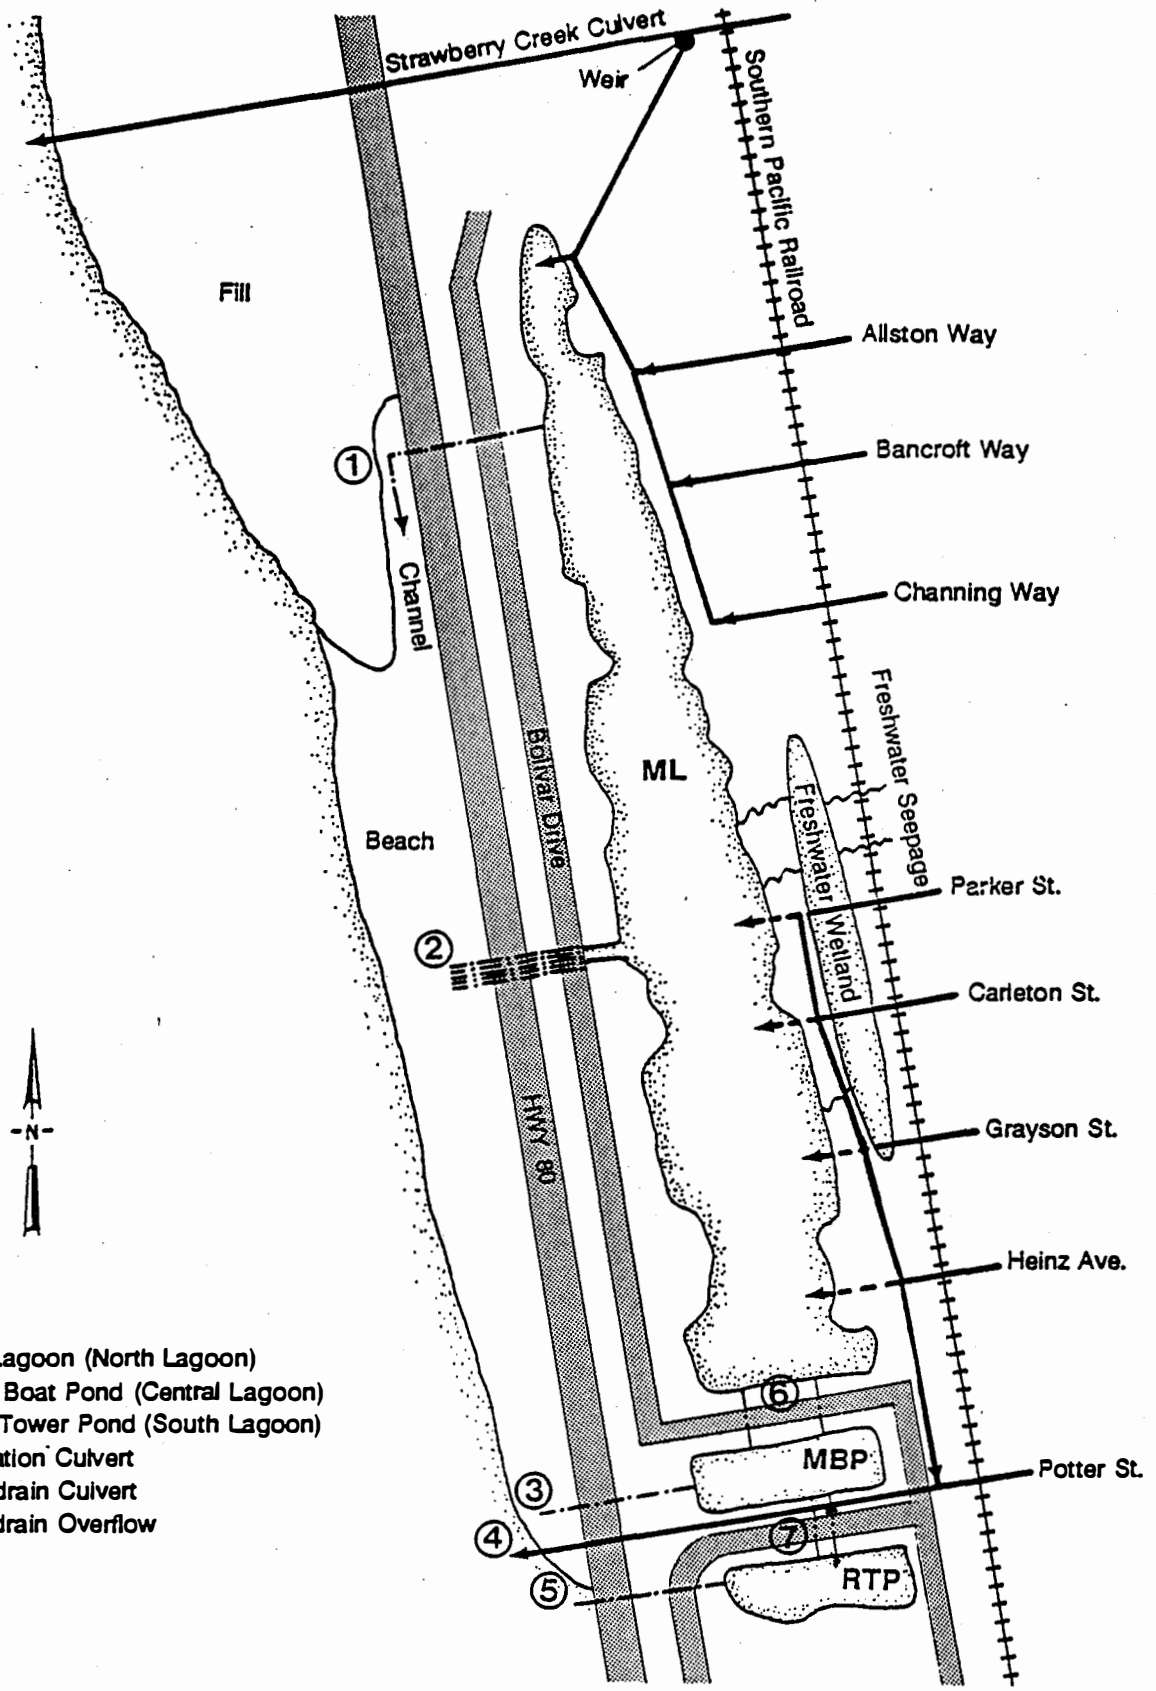
FIGURE
 1

The three lagoons contain a total of twelve culverts linking the ponds to the Bay and to each other. In addition, a number of gates and weirs have provided hydraulic control. At present, the circulation system is in relatively poor condition. Sand transport by wave action has blocked all of the Bay-lagoon culverts, except the Radio Tower Pond (RTP) culvert. As a result, tidal circulation is extremely limited.

Hydraulic Structures at Berkeley Aquatic Park
 (Modified from Ferlin [1983])

In addition to the above culverts, which connect the three ponds to the Bay and to each other, a series of storm system culverts (shown in Figure 1) drain to the east side of the main lagoon from developed areas of Berkeley further east. As originally constructed, these storm drains discharged directly into the main lagoon, since this represents the area of lowest elevation. Although dry during the summer, they convey relatively high flow during winter rainstorms. This rainfall runoff contains a variety of pollutants which degrade water quality in the lagoons. To partially alleviate this problem, a bypass culvert was constructed which captures the storm runoff from Parker, Carleton, Grayson, and Heinz Streets and conveys it to the Potter Street culvert and then to the Bay. This apparently functions during small-to-moderate rainstorm events; large events exceed the bypass pipe capacity and the excess is discharged to the lagoon. The northern storm drains in Figure 1 convey all runoff from Channing, Bancroft, and Allston Way directly to the north end of the main lagoon. In addition, a weir/diversion line in Strawberry Creek Culvert (the main culvert draining Central Berkeley and Strawberry Creek flow to the Bay) will discharge excess runoff from that culvert to the main lagoon during large rainstorms.

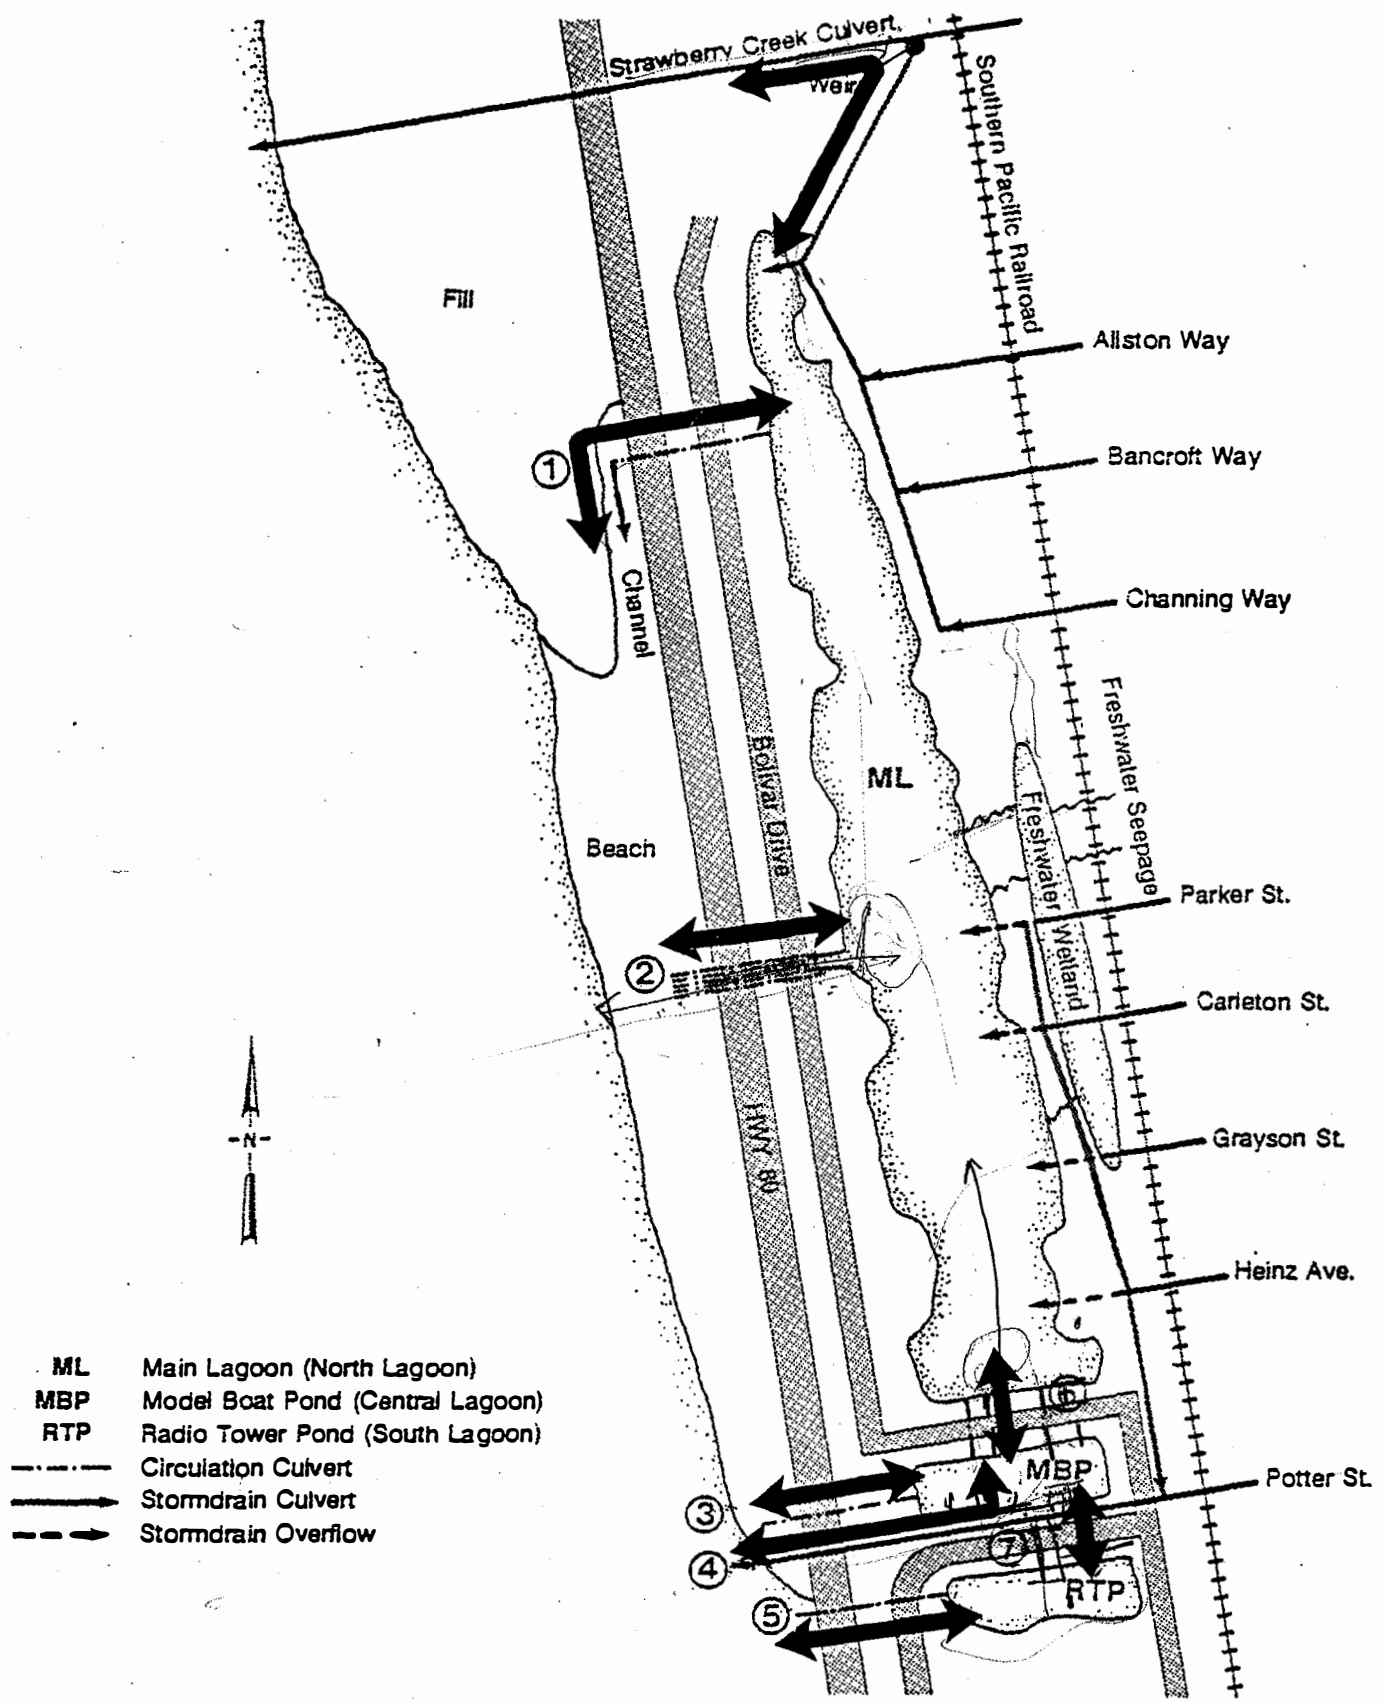
FIGURE
2

Potential Tidal Circulation Schemes at Aquatic Park

The hydraulic structures which affect Aquatic Park are shown in Figure 2 and described in Table 1. The results described below represent a reconnaissance-level inspection of the system. Surveying of culvert invert (flowline) elevations was conducted by the Berkeley Public Works Department.

In the main lagoon, five 24-inch diameter concrete culverts connect the lagoon with San Francisco Bay. On the lagoon side, the culverts end in a concrete box structure which previously

included flap gates to allow water inflow from the Bay while preventing outflow. At present, the tidal flap gates are inoperable. Furthermore, all five culverts are completely plugged with sand on the Bay side, preventing any tidal circulation at this time. It will reportedly cost about \$80,000 to clean the culverts. The problem of sand blockage has apparently been ongoing since the lagoon was originally built. The Berkeley shoreline experiences moderate wind-generated waves 1 to 3 feet high as a result of the strong summer westerly sea breeze. This suspends the Bay sand and carries it into the culverts. When the culverts are open and tidal water flows into the lagoon, the suspended sand is deposited as the water passes through the culverts. In the past, the flap gates for the lagoon side of the culverts prevented back flow, which would have helped scour the sand out of the culverts and carry it back to the Bay. Even if the culverts were cleaned and full tidal action allowed to enter and exit the culverts (i.e., no flap gates), it is possible that wave-generated sand transport may still block the culverts. However, blockage frequency would be greatly reduced. Blockage of these culverts represents the major water-quality problem affecting Aquatic Park at the present time.

In the north end of the main lagoon, a single 18-inch concrete culvert previously connected the Bay and the lagoon. Although there is no design document describing the original circulation of the lagoon, it is likely that the north culvert was intended to create a net counter-clockwise circulation, with Bay inflow through the 5 main culverts and outflow through the

north culvert. However, on the Bay side of I-80, extensive fill has been placed and the end of the culvert buried. It is completely inoperative at this time.

In the south end of the lagoon, two 18-inch culverts connect the main lagoon with the model boat pond. These are always open (no gates), and water levels in these two water bodies are the same. These culverts are apparently functional, although there may be some accumulated sediment. A single culvert also connects the model boat pond to the Bay. This culvert is non-functional, with the end on the Bay side completely buried in sand (its location was tentatively identified, and it probably could be excavated and flushed if desired). Two short (one 18-inch, one 24-inch) culverts also connect the model boat pond to the Potter Street outfall. These two culverts had slide gates, now deteriorated, on the MBP side.

The Radio Tower Pond (RTP) is connected to the Bay by a single 24-inch RCP; although there is a slide gate on the RTP end of the culvert, this is apparently never closed, and the culvert is open to full tidal inflow and outflow. On the Bay side, this culvert (unlike the five main lagoon culverts, the north culvert, the MBP culvert, and the Potter Street outfall) is not experiencing sand blockage. There are three reasons for this:

- a. Clean the existing 5 main culverts to the Bay. Allow increased tidal flooding to reduce future sediment deposition.
- b. Repair and modify the headwall structures on the lagoon side of the five culverts as needed to meet circulation goals.
- c. Provide an intake structure for the five culverts on the Bay side to prevent sand blockage.
- d. Locate and excavate the Bay side end of the north culvert in the main lagoon to restore tidal circulation.
- e. Use tidal circulation from the Strawberry Creek culvert as a source of water to the main lagoon.
- f. Expand the daily range of water elevations in the lagoons to improve water quality.
- g. Examine various combinations of flap gate structures to create a net circular flow of water through the lagoons.

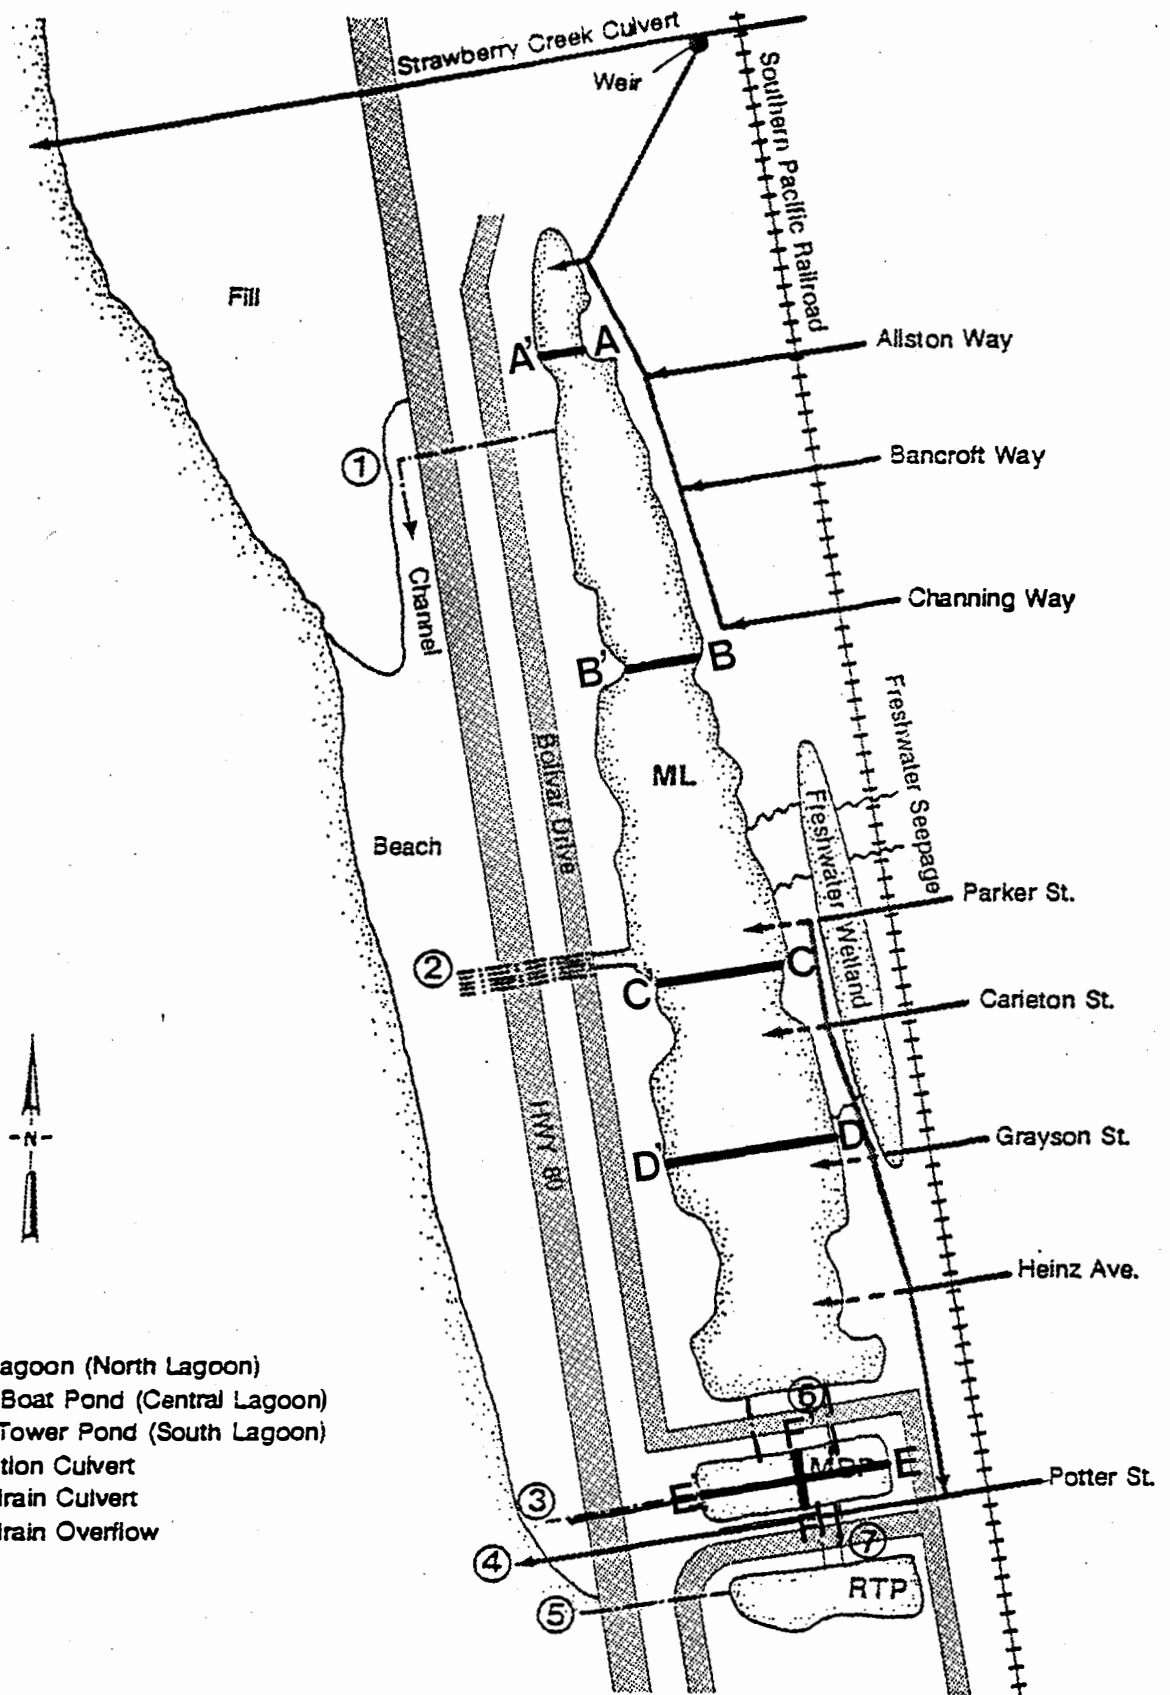
FIGURE
3

Location of Lagoon Cross-Sections
