Aquatic Park Natural Resource Management Study (NRMS)

The City of Berkeley

July 2003

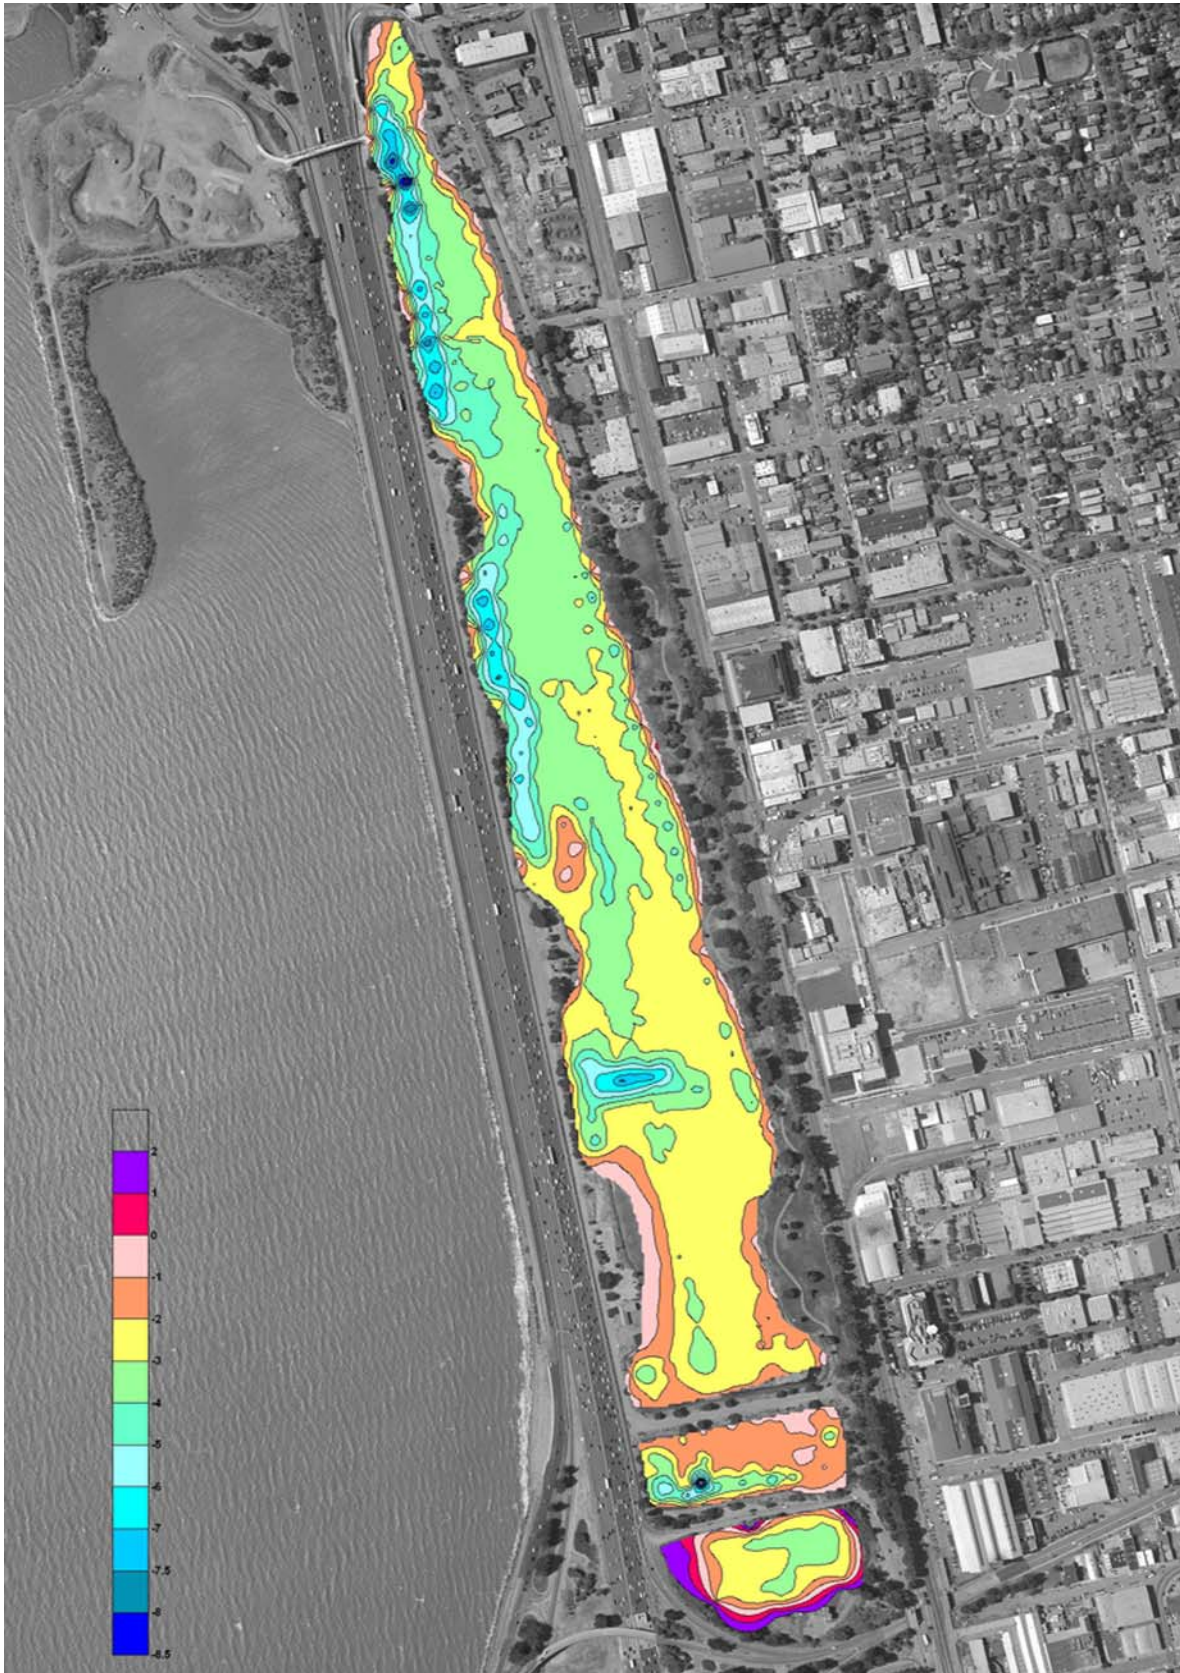
Figure 2-1. Aquatic Park Bathymetry (ft. NGVD)

In 2002, Sea Surveyor created a new bathymetric map of the Main Lagoon, the MYB, and the RTP (see Figure 2-1). The bathymetric map covers only the water areas of the lagoons and indicates depths in feet to 0.1 foot units. The condition of the culverts of the Main Lagoon, MYB and RTP were examined at Aquatic Park (see Figures 2-2, 2-3 and 2-4). The condition and invert elevations of the main culverts were determined. The location and elevations of the Strawberry Creek culvert and stormwater overflow weir were also determined.

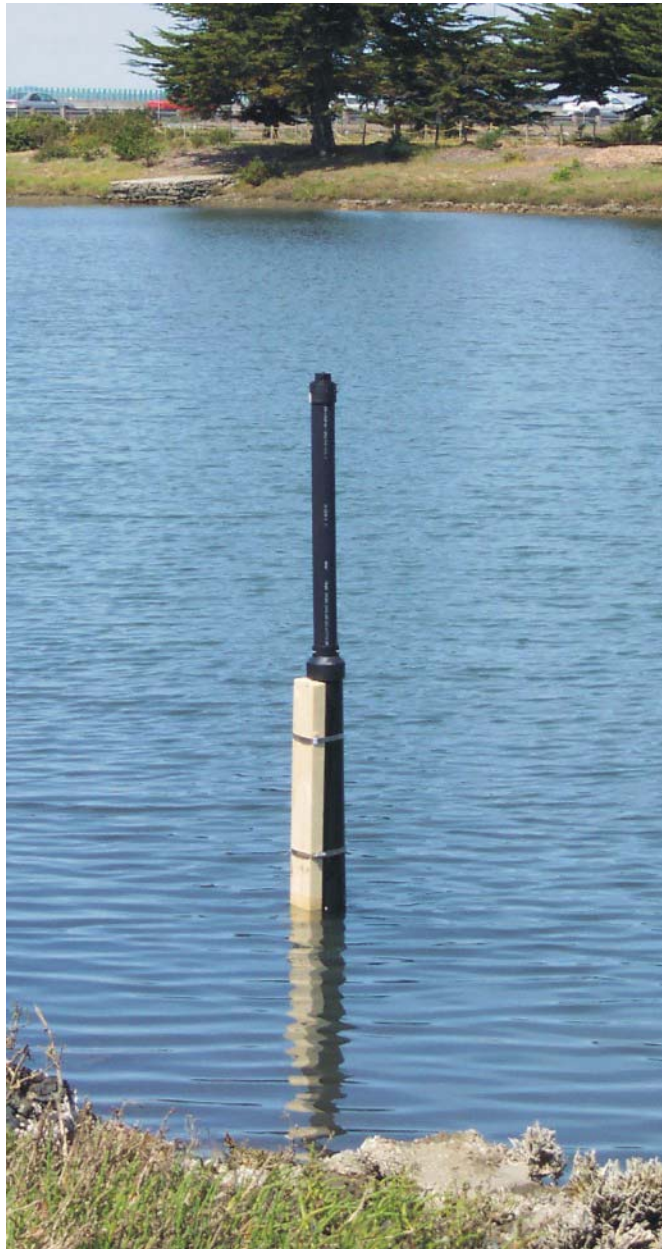
Figure 2-5. Recording Tide Gage Installed in Model Yacht Basin

Two recording tide gages were installed - one in the Bay, near the Main Lagoon inlet-outlet culverts and one in the Main Lagoon on the culvert headwall or terminus (see Figure 2-5). There were two different tidal monitoring periods - the first was May 29-July 1, 2002 and the second was April 5-16, 2003. The first set of readings were completed in 2002, prior to a clearing of the culverts by the City; the second set of readings were completed in 2003 to measure changes in tidal levels after cleaning the culverts. Each time, the tide gages were left in place for over two weeks and collected data at 15-minute intervals. During the first tidal

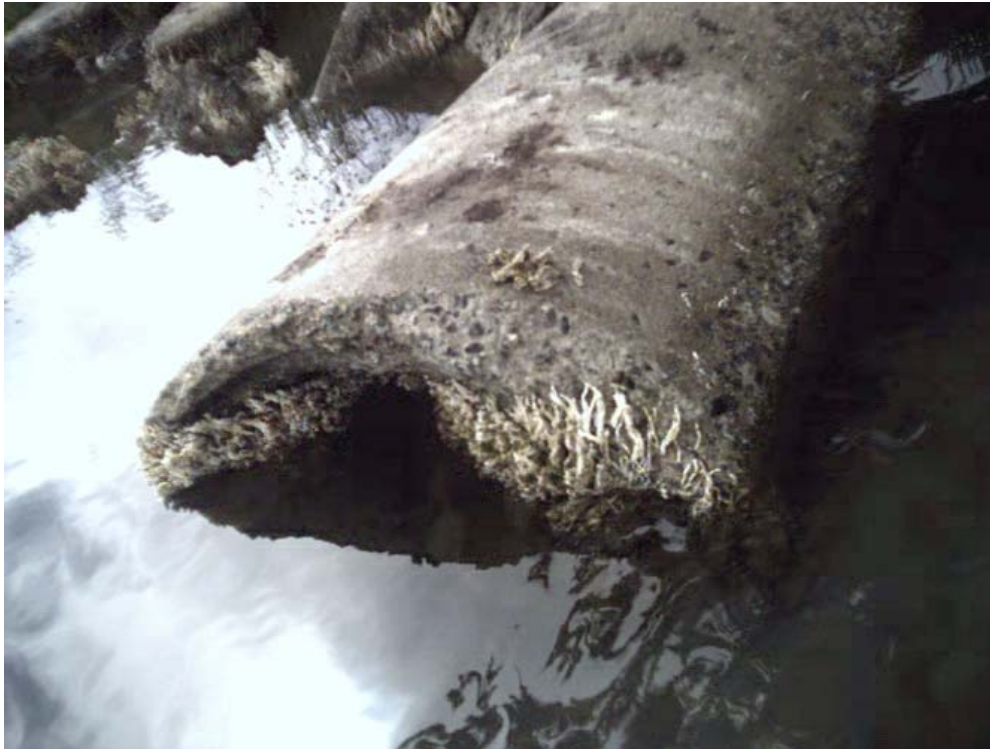
Figure 2-8. Mouth of Culvert Showing Growth of Marine Worms that Limit Flow

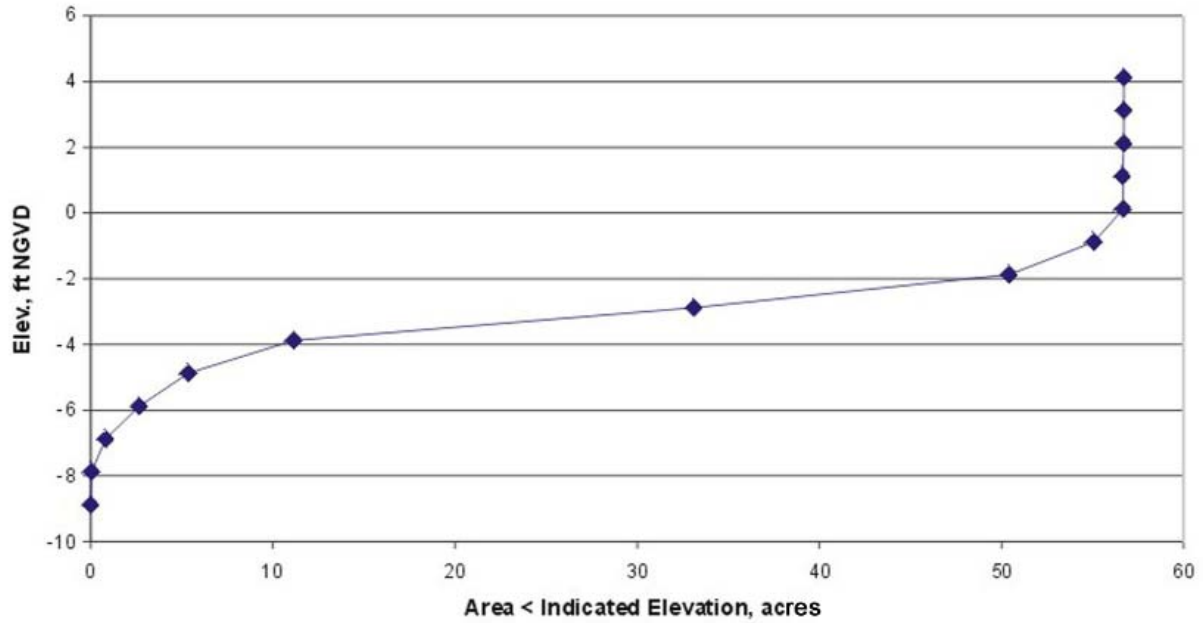
Figure 2-11. Main Lagoon Stage-Area Curve

An important feature of the tidal regime in systems with restricted tidal flow is the phenomenon of "tidal pumping". In a natural tidal system, the elevation of the high and low tides varies over a monthly period. There are the very highest of the high tides termed spring tides and the very lowest of the low tides termed neap tides. Although the lagoons have a very limited tidal range, tidal heights do show an increase and decrease over the month in the Main Lagoon and MYB associated with neap and spring tides. The result is a zone around the edge of the lagoons that is inundated continuously for 4-5 days every month, and then exposed and dry for 4-5 days every month.

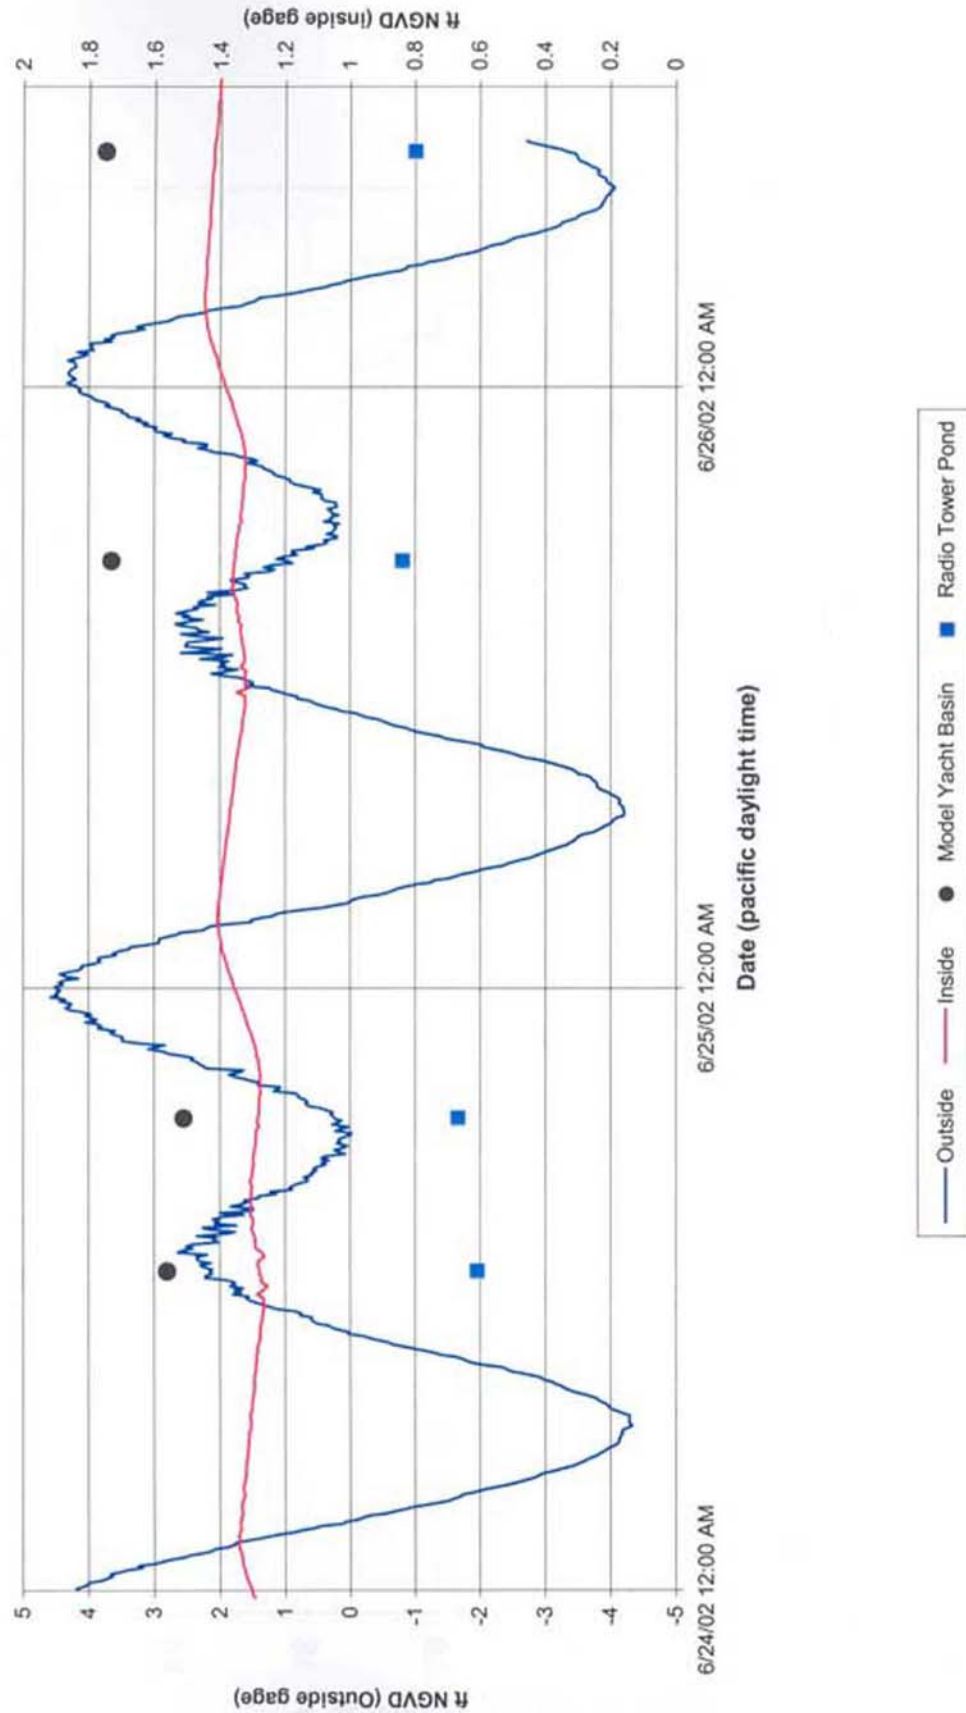
Figure 2-16. Tide Heights at Aquatic Park, During First Tidal Monitoring Period, June 24 - 27, 2002 -Before Culverts Were Cleaned by City

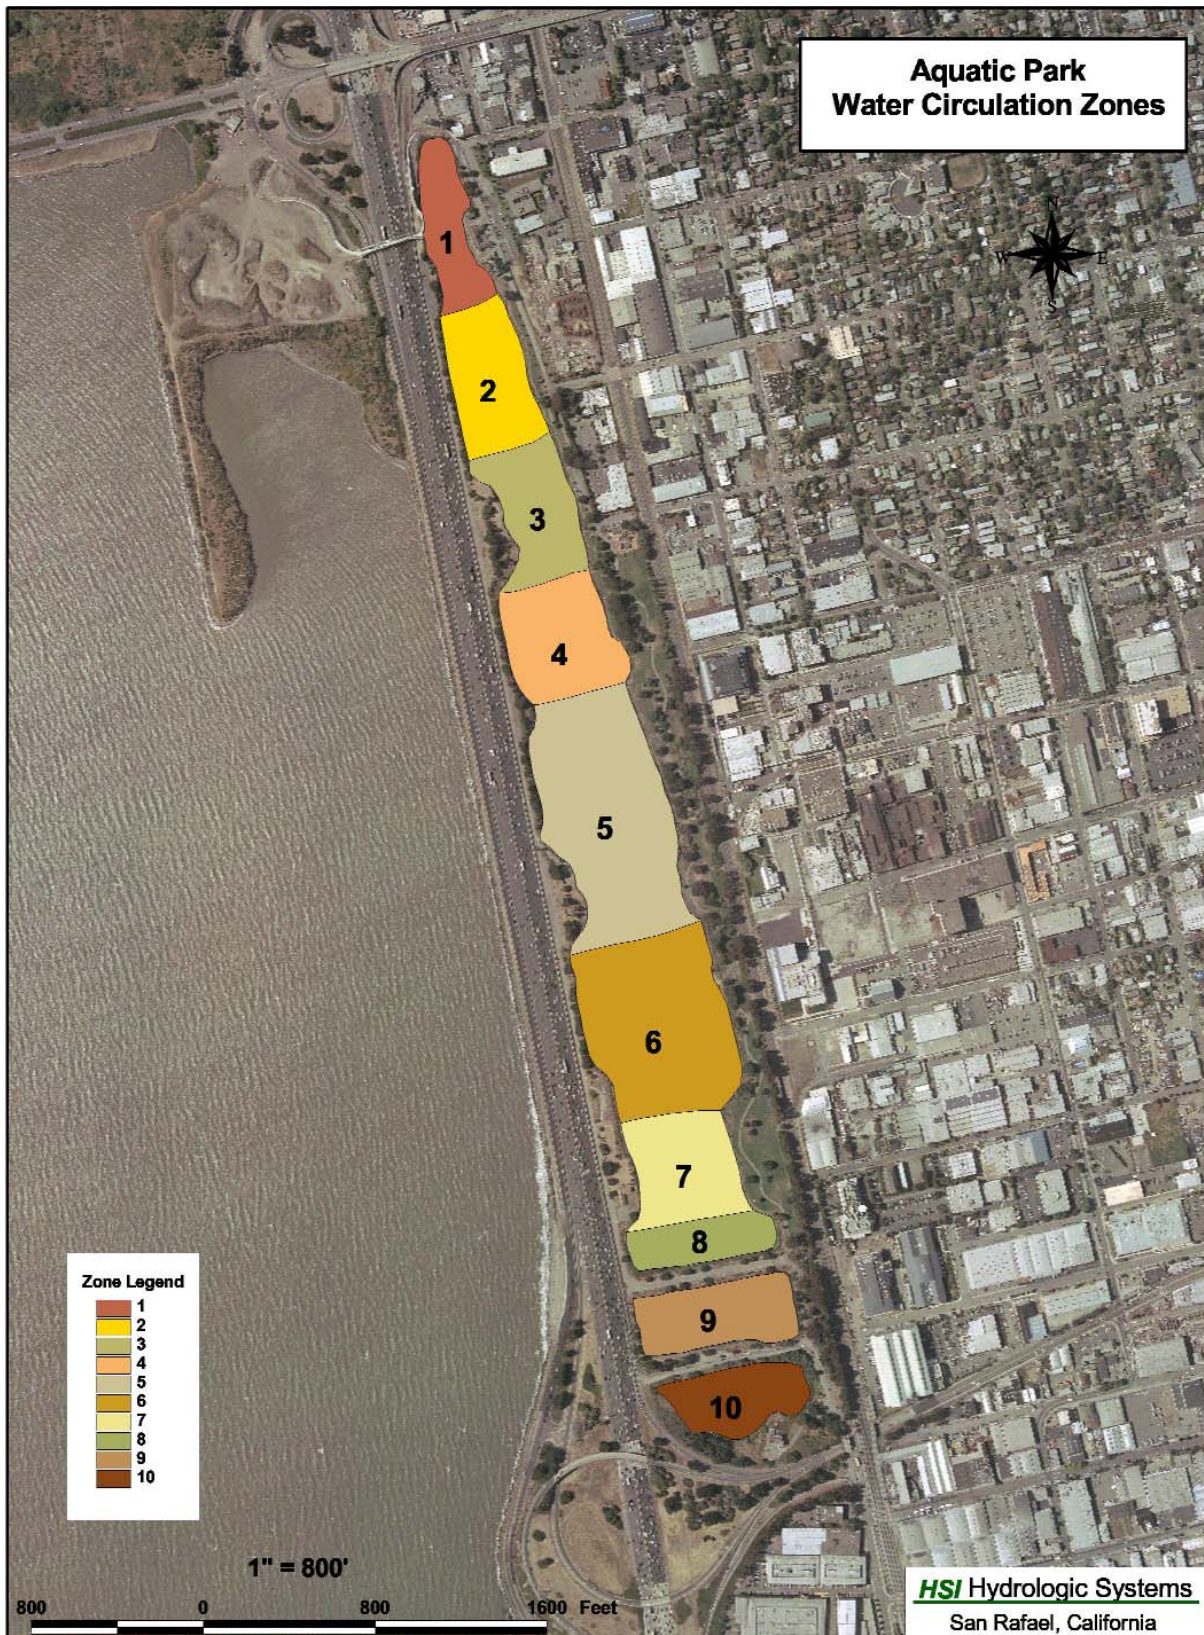
Figure 3-1. Aquatic Park Water Circulation Zones

Tidal height changes under each alternative are summarized in Table 3-1. To demonstrate the level of water quality improvement produced by each alternative, the lagoons were broken into zones (see Figure 3-1). The percent improvement of water volume exchange or circulation for each zone is then reported in Table 3-2 for each alternative.
